TECHNICAL REPORT ARCCB-TR-97021

HYDROGEN CRACKING DURING SERVICE OF HIGH STRENGTH STEEL CANNON COMPONENTS

SEPTEMBER 1997

**US ARMY ARMAMENT RESEARCH,
DEVELOPMENT AND ENGINEERING CENTER
CLOSE COMBAT ARMAMENTS CENTER
BENÉT LABORATORIES
WATERVLIET, N.Y. 12189-4050**

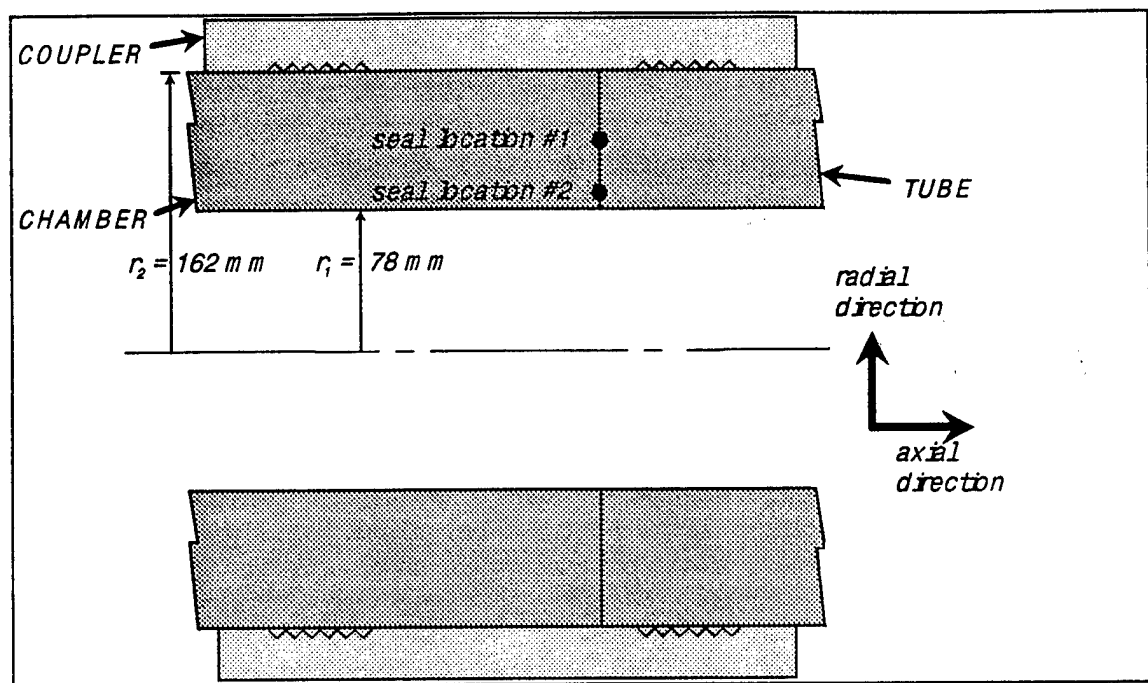
FIG. 1 - Sketch of Cannon Configuration and Nomenclature

The general configuration of the cannon components that sustained rapid cracking is shown in Figure 1. Cannon chamber and tube sections are connected using a cylindrical coupler with segmented threads on its inner surface. As the coupler draws the chamber and tube together, a preload is applied to the pressure seal between the two sections. Two seal locations that have experienced separate occurrences of rapid cracking are described here. Seal location #1, shown in Figure 2, is at a position about midway through the 84-mm wall thickness of chamber and tube. A triangular-shaped copper beryllium seal was used, along with a vented guard ring that allowed pressure on the seal while preventing a direct flow of cannon propellant combustion products onto the seal.

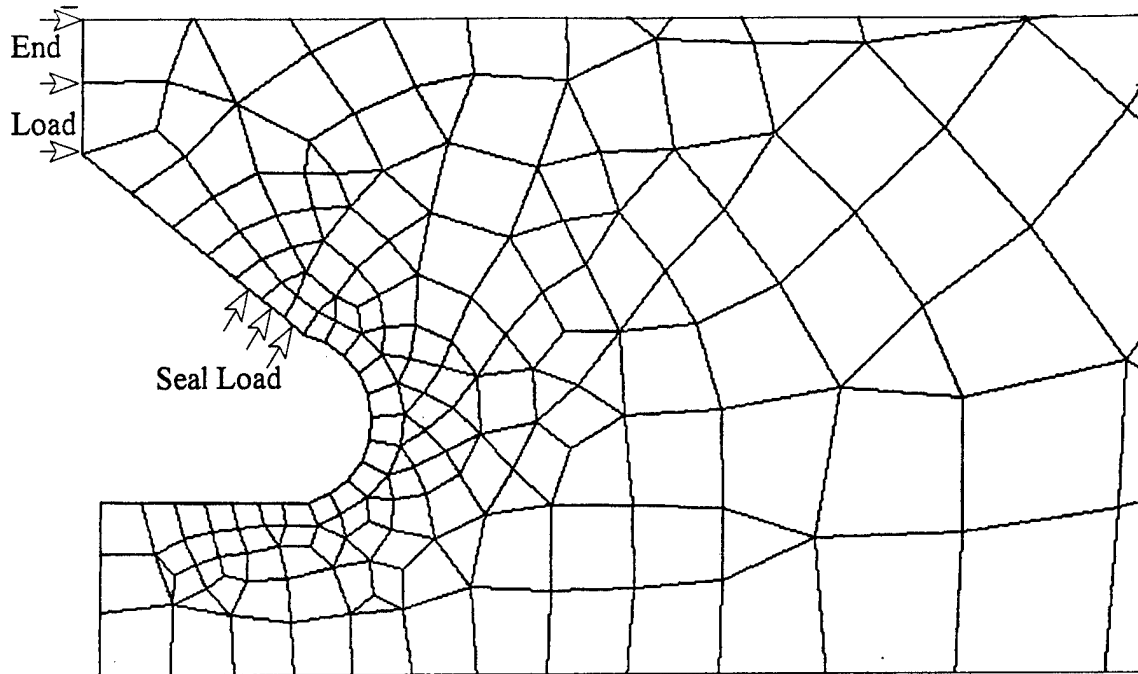
FIG. 7 - Finite Element Grid for Analysis of Cracking at Location #2

The important unanswered question at this point of the fracture case study was whether or not a significant sustained tensile stress could be accounted for at the location #2 failure location. A finite element analysis was performed to answer this question, using the ALGOR program. The portion of the grid in the area of the seal pocket is shown in Figure 7. The two types of sustained loads discussed previously were considered in the analysis and are shown schematically in Figure 7. The end load is caused by the contact between the chamber and tube sections of the cannon as they are drawn together by the coupler, see again Figure 1. An average end load of 156 MPa was determined from prior work (ref 2), based on typical loads on the coupler threads. The seal load, the other type of loading considered, was determined from the yield and ultimate strengths of the seal material given earlier and the significant values of triaxial stresses that are present in contact stress situations. Based on prior work (ref 7), the contact stresses are 2.97 times larger than the uniaxial yield strength of the material, the lower strength seal material in this case. Using this value of 2.97 and the average of the yield and ultimate strengths of the seal material, 1019 MPa, gives a seal load of 3023 MPa.
